Report of Marine Survey

GOOD BOAT

Tradewind / True North 34

November 07, 2015

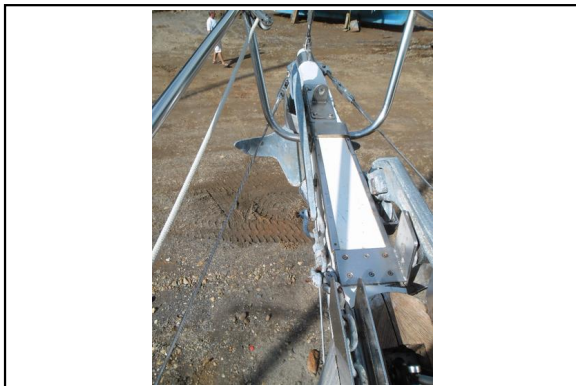
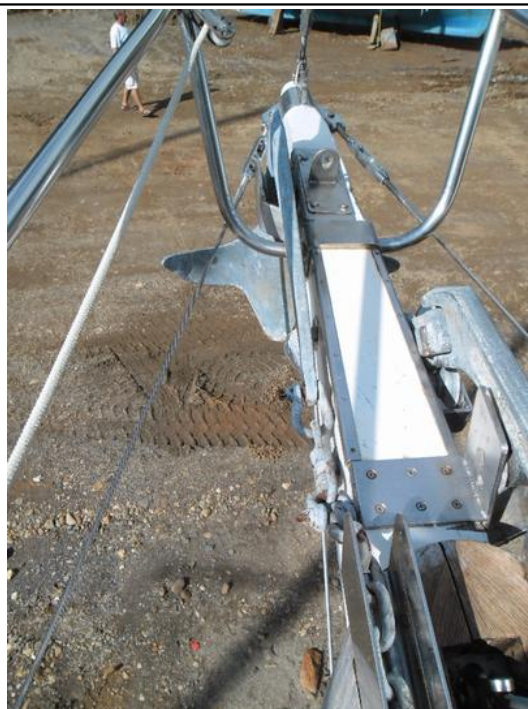
SAM_0222.JPG

At bowsprit (Photo SAM_0222)

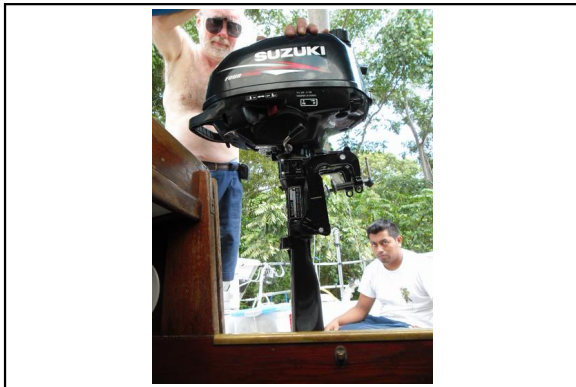
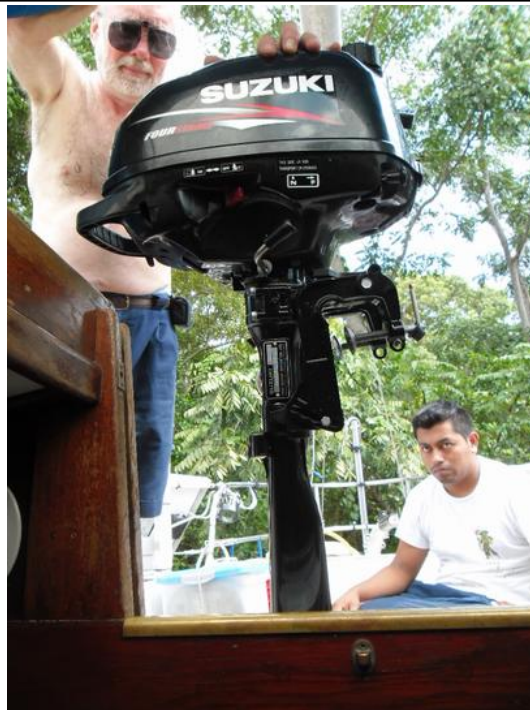
SAM_0312.JPG

New, unused 2.5 HP Suzuki 4 stroke outboard Model: DF2.5 Serial Number: 00252F-214584
(Photo SAM_0312)

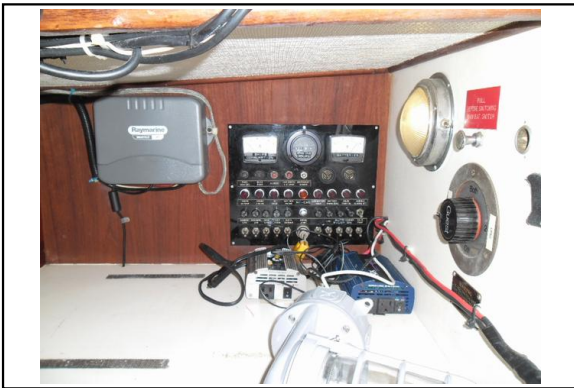
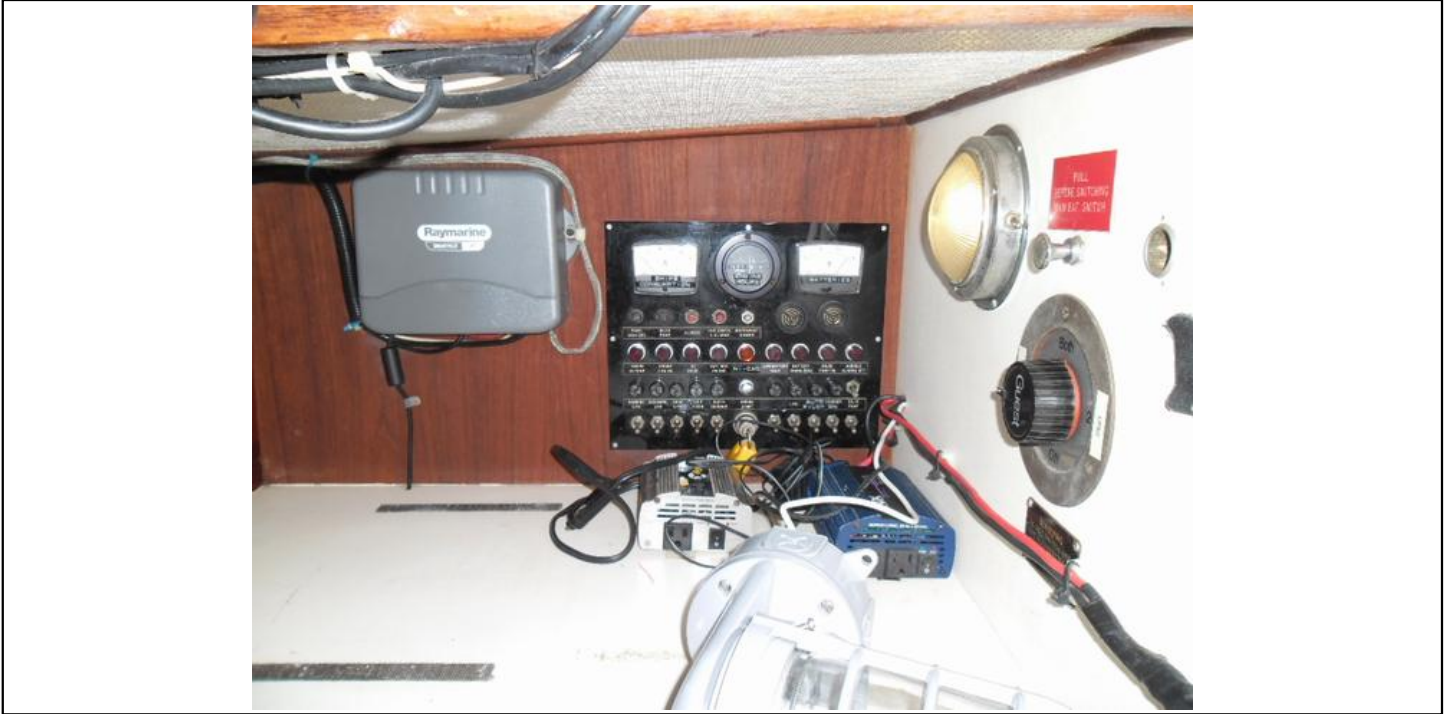
SAM_0306.JPG

Over current protection provided by bus type fuses and circuit breakers located at navigation station with good access (Photo SAM_0306)

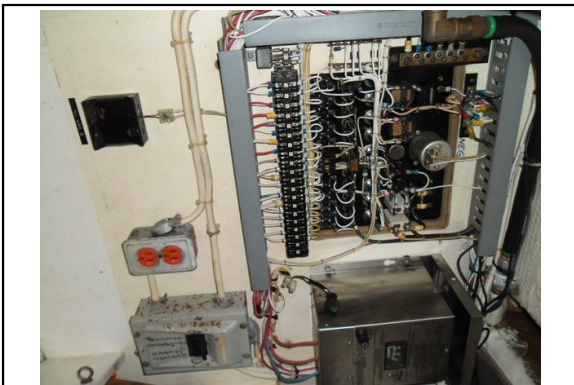
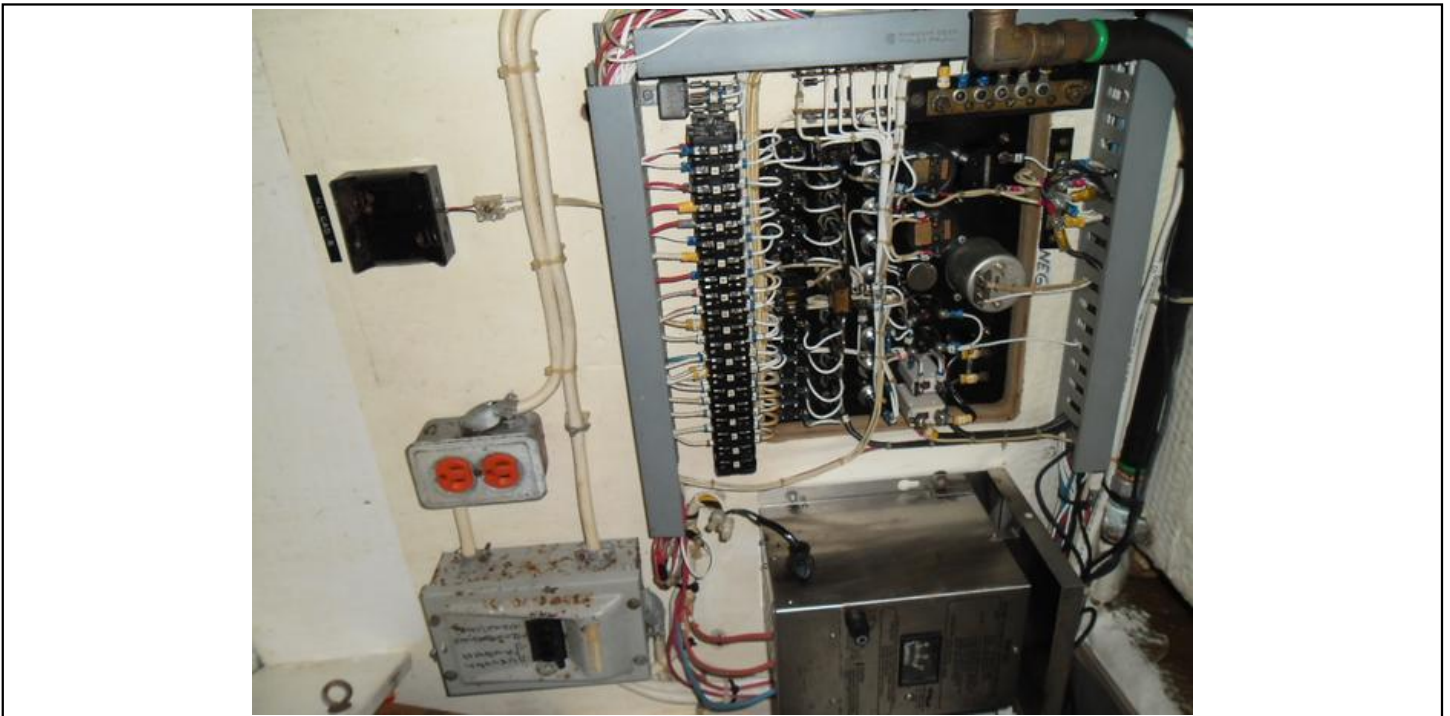
SAM_0324.JPG

All wiring seen well routed and supported throughout vessel (Photo SAM_0324)

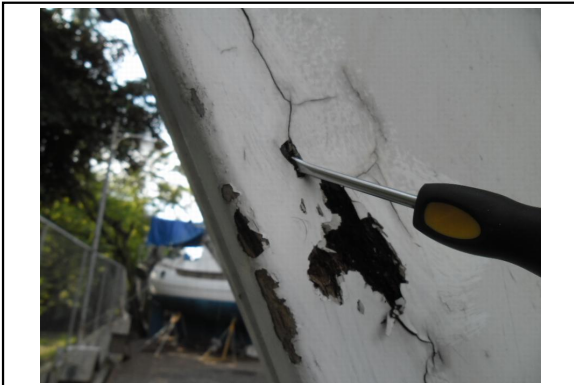
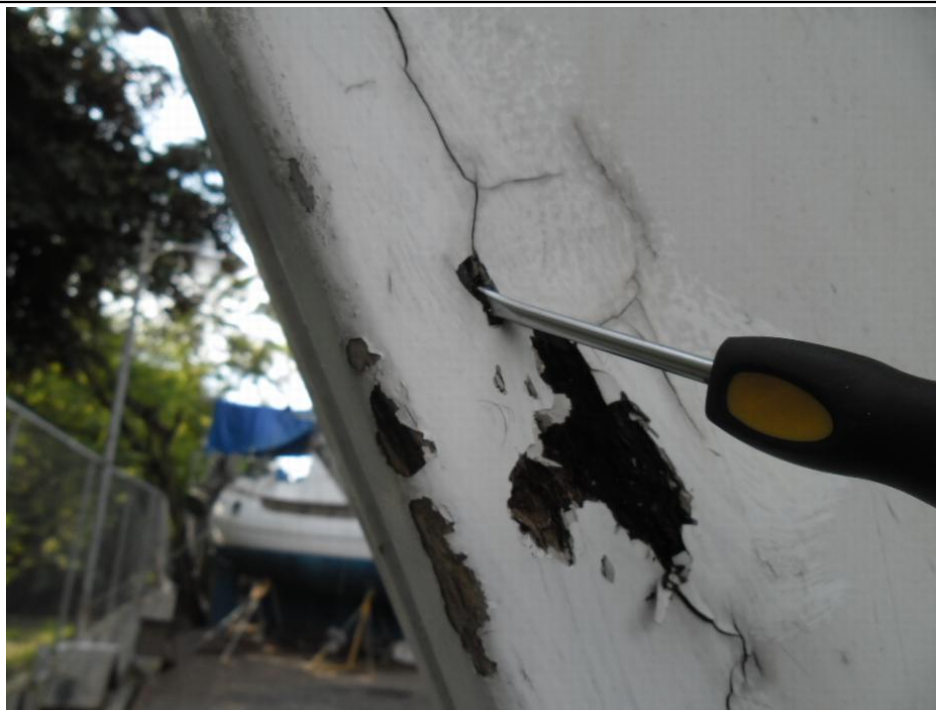
SAM_0202.JPG

***B.1**

Areas of rotted wood were observed in tiller system (Photo SAM_0202)

Tiller steering.	
FINDINGS	RECOMMENDATIONS
Areas of rotted wood were observed in tiller system (Photo SAM_0202)

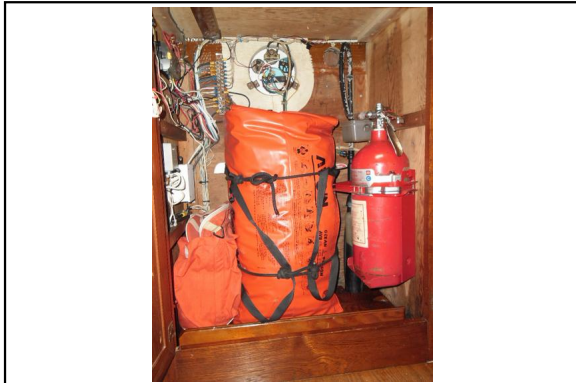
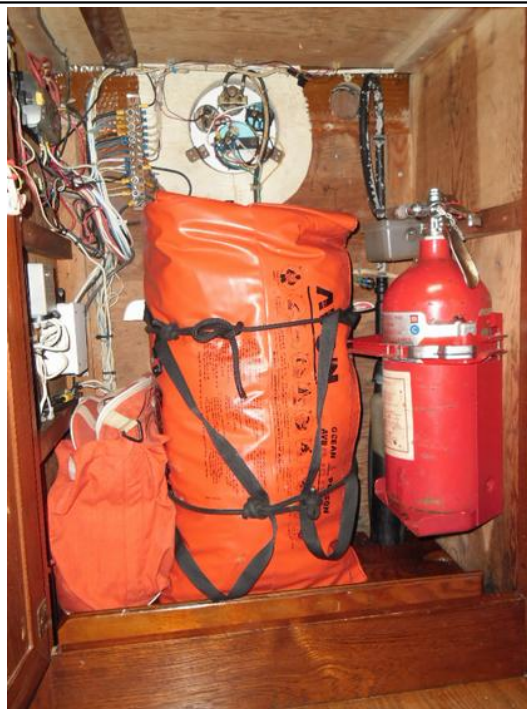
SAM_0297.JPG

*C.1

No service date was found and owner reports unit has not been serviced for several years.

Avon 4 person valise type (Photo SAM_0297) Serial Number: AV800-087K405	
FINDINGS	RECOMMENDATIONS
No service date was found and owner reports unit has not been serviced for several years.	<i>A life raft is not required for this vessel however it is recommend equipment for offshore operation.</i> NOTE: <i>It is not possible to service life rafts in Central America. Life raft should be serviced upon return to the United States.</i>

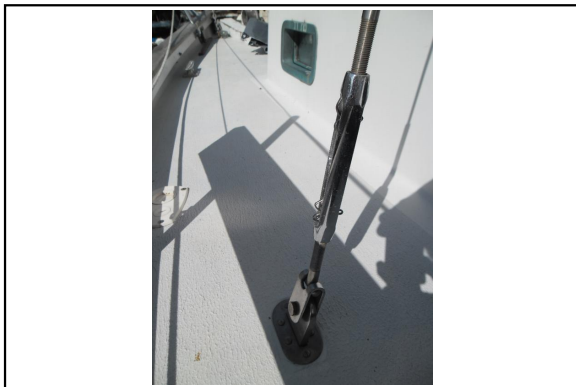
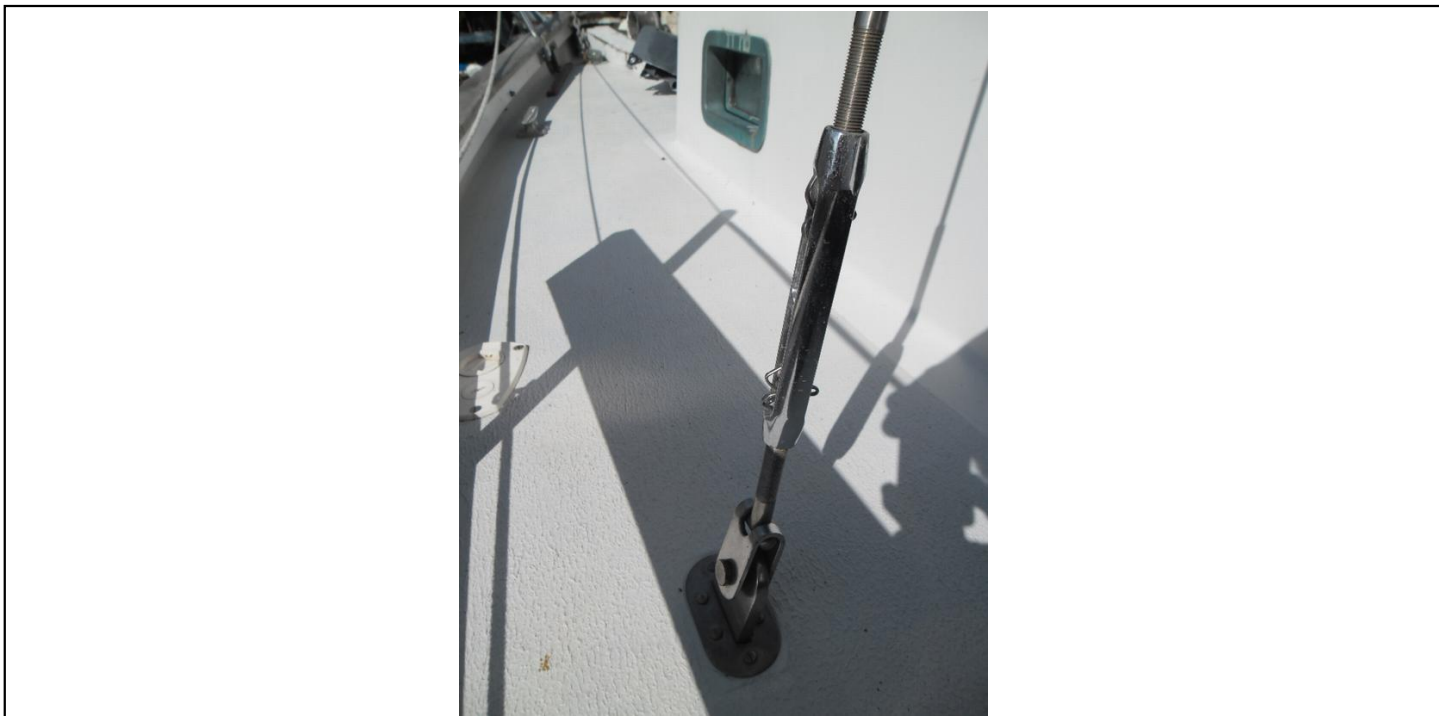
SAM_0243.JPG

Open body chrome plated bronze seen in good condition with cotter pins in place (Photo SAM_0243).
